Hirst, E, Brett, A, Thomson, A, Walker, P & Harris, R 2008, 'The structural performance of traditional oak tension and scarf joints', Paper presented at 10th World Conference on Timber Engineering, Miyazaki, Japan, 2/06/08 - 5/06/08.

The Structural Performance of Traditional Oak Tension & Scarf Joints

Edward HIRST, Andrew BRETT, Andrew THOMSON
University of Bath, UK

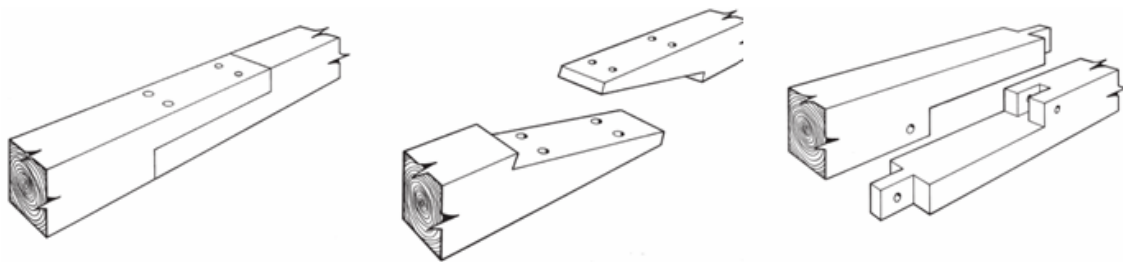
Fig. 1 – Halved, splayed and bridled scarf joints

There are three main classes of Scarf joint [5]; halved, splayed and bridled. A halved scarf is a lap whose surfaces are parallel with the timbers', it is structurally the simplest, and the easiest to manufacture. This has led to this joint becoming the most widely used. A splayed scarf has the lapped surfaces sloping (a bridled scarf adds tenons). A bridled scarf takes the form of an open mortice and tenon.

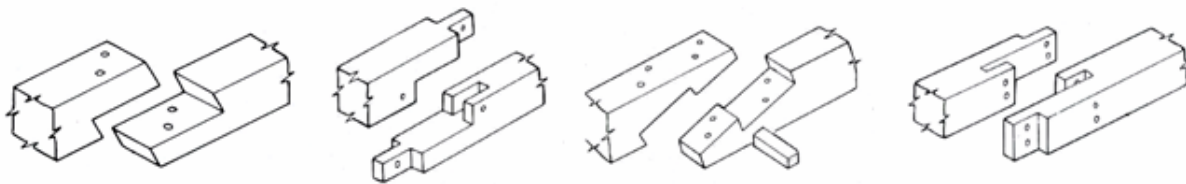
Fig. 2 – Scarf joint selection

Four different types of scarf joint were selected; the under-squinted butt in halved scarf with two pegs, side-halved & bridled with two pegs, stop-splayed & tabled scarf with key and four pegs, and the face-halved and bridled scarf with four pegs. These joints were chosen based upon carpenters guidance and a need for good structural comparison. Diagrams of the four joints are respectively organised in Fig. 2 below.

The beam sections tested were 200 X 150 mm (8" X 6"), the most commonly used section dimensions for top plates within an oak timber frame. All peg holes were 19mm (3/4") in diameter and in keeping with traditional practice the peg holes on one side of the scarf were offset by 3mm with respect to the other side of the joint, tightening the joint when the pegs were driven through.

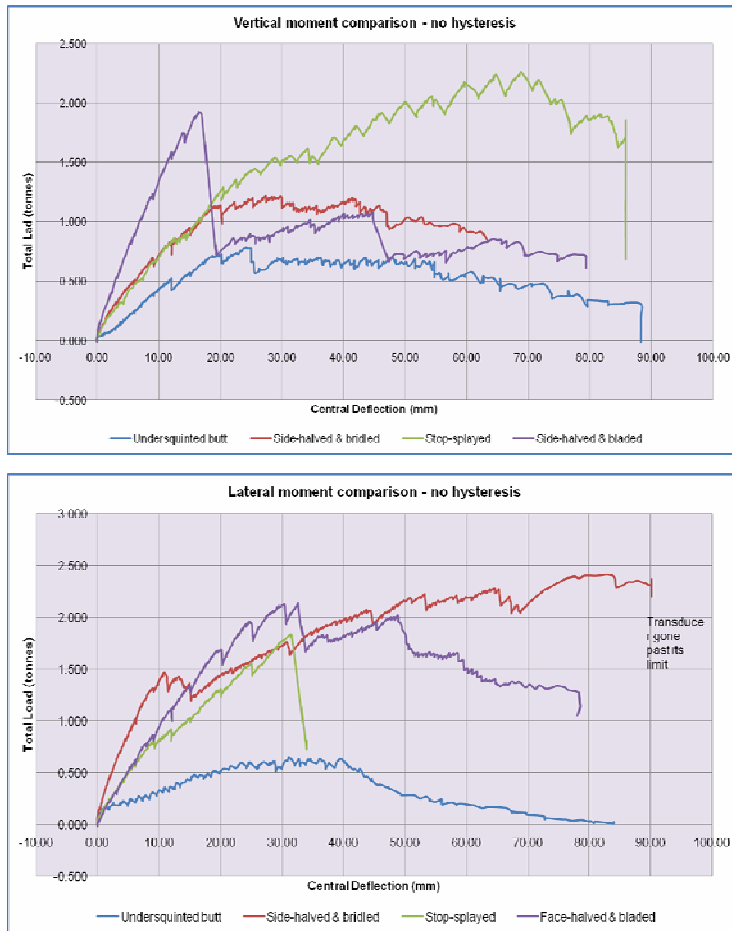
Fig.4 – Load v. Displacement outputs

The laterally loaded configuration of the side-halved & bridled joint was the stiffest joint out of all eight bending tests. This is a result of the greater lever-arm between the pegs and the greater depth

of the section used to transfer the bending stresses. This joint also displayed the greatest strength although at unserviceable deflections. The improved performance of this joint can in part be attributed to its use of pegs.

The pegs were critical elements in all eight tests. The failure of each joint was through cleavage of the main timbers and not through shear of the pegs. Cleavage of the timber required less energy than shearing the pegs, highlighting the importance of ensuring the pegs are of high quality and that in the case of historic frames they are structurally sound. By demonstrating that failure can be limited to cleavage, the capacity of the joint can be more readily predicted. Equivalent values of stiffness obtained from solid section testing were deemed unreliable in some cases due to the variations in the timber used. It is felt that this reduced the value of Young's Modulus for the solid section specimens. This is evident from reviewing the stiffness performance factors, which are extremely high. In one particular case the jointed section is stiffer than an unjointed section (*Fig. 4*)

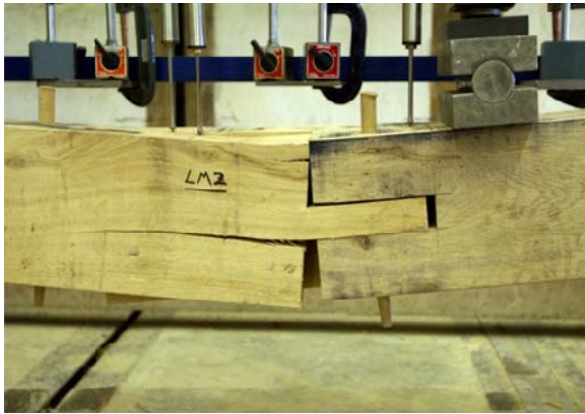
Fig. 5 Cleavage initiation on side-halved joint

The bending performance factors compare well to published results. Although some of the laterally loaded specimens were able to use the full depth of the 200mm deep beam, there was no significant increase in the maximum moment when compared to their vertically loaded counterparts. This can be attributed to the critical failure mechanism within most of the joints which was cleavage, (*Fig. 5*). This attributed to the ultimate failure within all of the joints as opposed to shear.

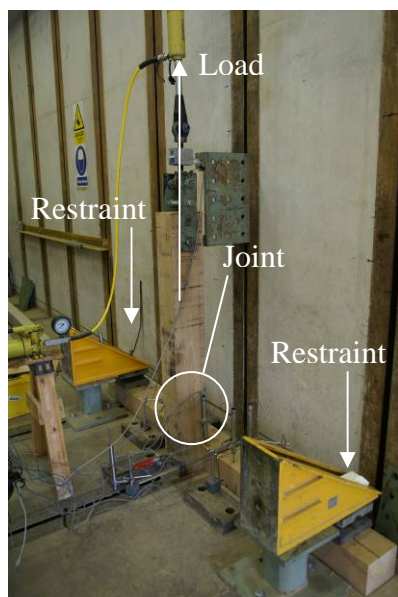
Fig. 6 Testing setup

The experimental setup was common for all the joints tested and is shown in Fig. 6. Due to space restrictions it was necessary to test the specimens in the vertical alignment shown. The load was applied using a hydraulic jack which had full articulation between itself and the loaded member in order to minimise the effects of any load eccentricity. Failure of the specimens was reached in six to ten minutes.

All joints were loaded in pure tension under short term loading. The tests were terminated at connection failure which was defined as a complete loss of load resistance. This generally corresponded to the complete withdrawal of the vertical member. Throughout the loading of the specimens the displacements of the cross beam and the relative vertical displacements of the tension members were recorded in conjunction with the applied load.

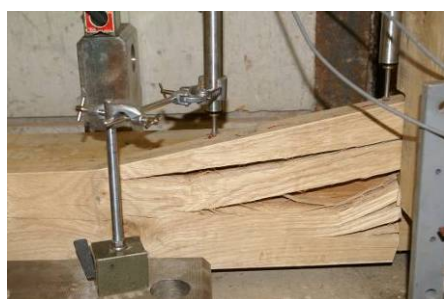
Fig. 7 Failure of lap dovetail joint

All the lap dovetail joints, including those with an additional normal force, failed due to the cross member splitting as the vertical member was pulled out. The vertical members suffered very little damage during the failure of the joint. Predominantly the cross members tended to split flush to the back of the dovetail rebate and the timber would then shear at a depth approximately equal to the thickness of the dovetail (Fig. 7). In general only one of the two sides bearing on the dovetail completely failed by splitting. The opposite side displayed some cracking but to a much lesser extent. The failure pattern was related to the grain pattern and was influenced by weaknesses in the members such as knots. One exception to this series of failures was the complete failure of the cross member. The splitting began in the same fashion as the other tests, flush with the back of the dovetail rebate. However due to an unforeseen flaw the split ran through the full depth of the cross beam resulting in complete failure. The joint, which is listed as test two in the results table, showed no significant loss of strength in comparison with the other joints.

The failure mode of the dovetail lap joint was seen to be similar to that shown in Fig. 7 for each of the first six tests. Based upon this observation it was decided that a series of tests would be carried out to investigate the behaviour of the area of timber providing restraint against withdrawal of the dovetail. The area of failure was controlled by cutting slots beside the dovetail of equal depth, thus limiting the shear area. It was anticipated that this would provide an insight into the distribution of stresses over the shear area and potentially provide the basis for a simple conservative design check

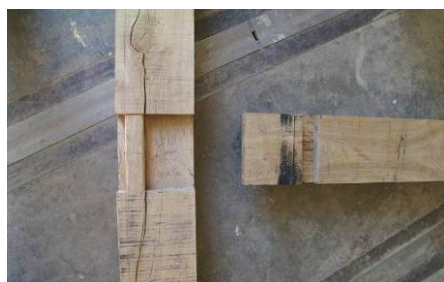
Fig. 8 Failure of lap cog joint

The lap cog failed in a similar way to the lap dovetails, in that the cross member failed due to splitting along the grain whilst the vertical member remained relatively undamaged. Shown in Fig. 8, the cross member split failure can be seen to clearly

follow the grain in line with the raised section upon which the cog bears. The failure mode of the joint with the additional normal force was almost identical to that of the non-loaded connection.
